# INSPECTION REPORT

For the Property at:  
**[ADDRESS]**

Prepared for: [NAME]  
Inspection Date: Sunday, December 9, 2012  
Prepared by: Andrew Marioselva BSc,CHI

# WARRANTY

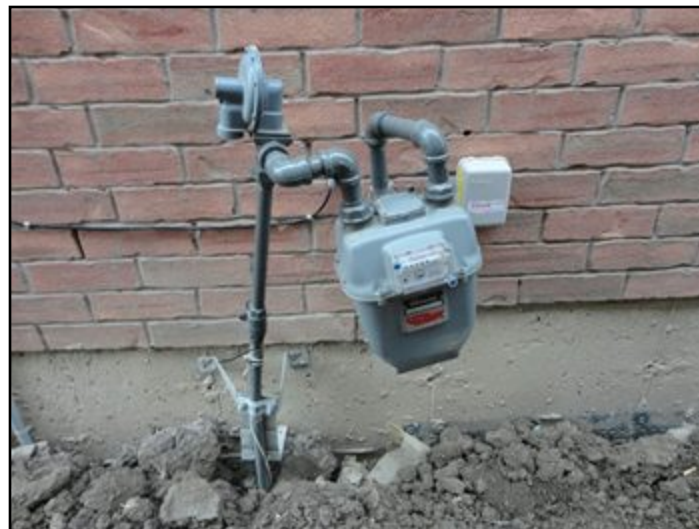
1. *Mechanical damage*

1. **Condition:** • [Mechanical damage](#)

**Location:** Yard

**Task:** Repair or replace

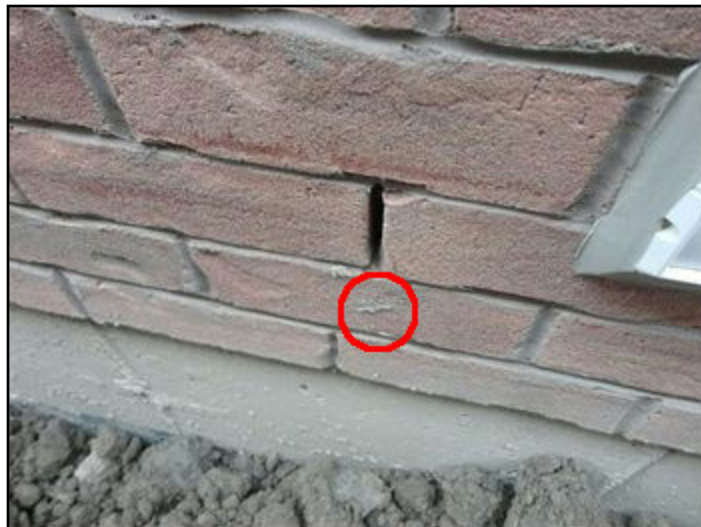
3. Mortar splatters and stains on exterior...

**3. Condition:** • [Mortar splatters and stains on exterior masonry](#)

**Location:** Exterior Wall

**Task:** Clean

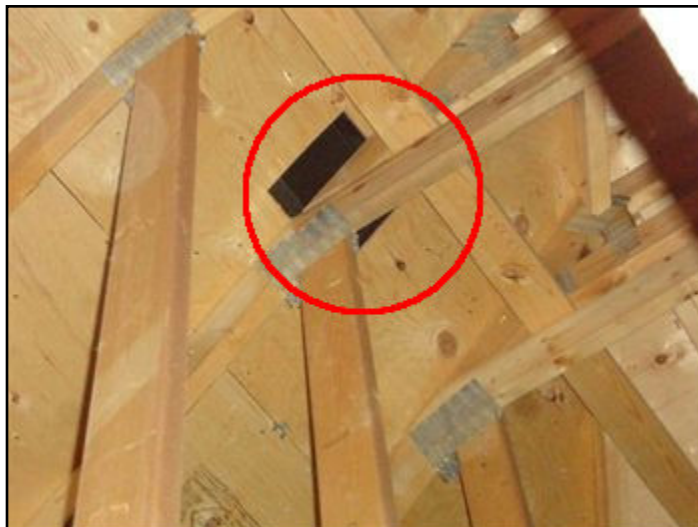
4. Inadequate attic ventilation

### 4. Condition: • [Inadequate attic ventilation](#)

Blocked attic venting

Location: Attic

Task: Correct

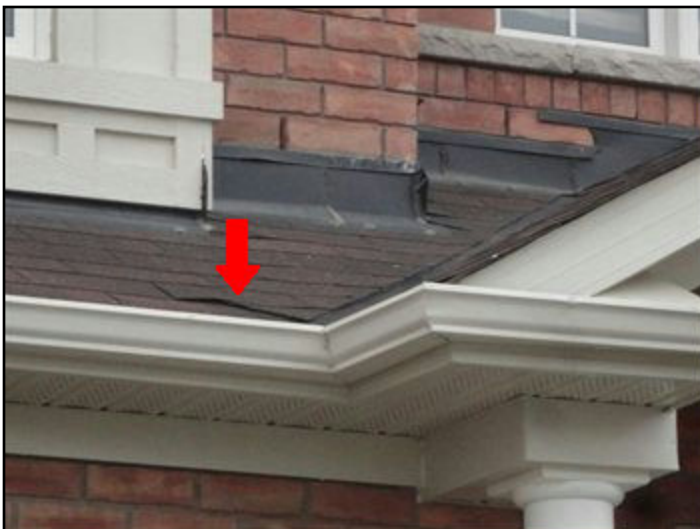
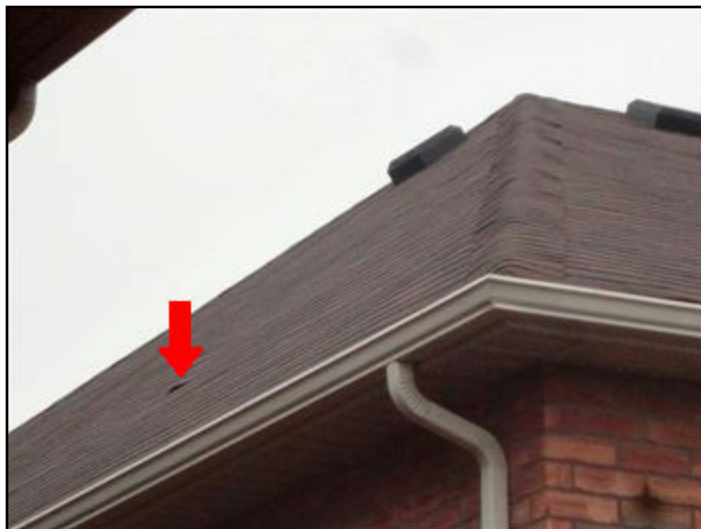
5. Asphalt shingles not sealed

### 5. Condition: • [Asphalt shingles not sealed](#)

Location: Front Exterior Roof

Task: Repair

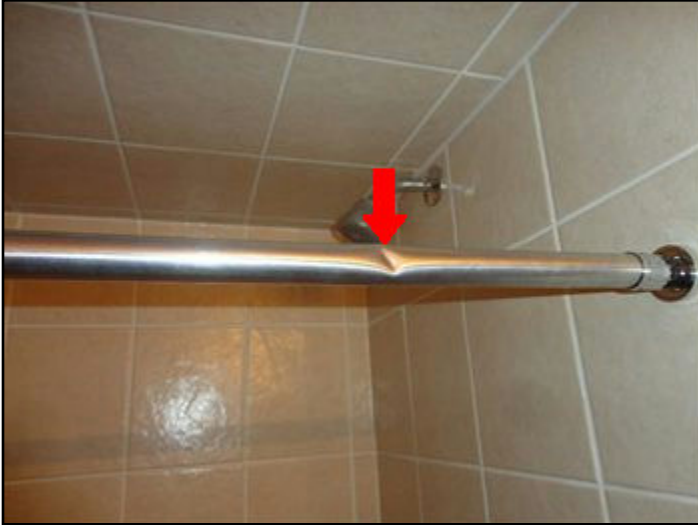
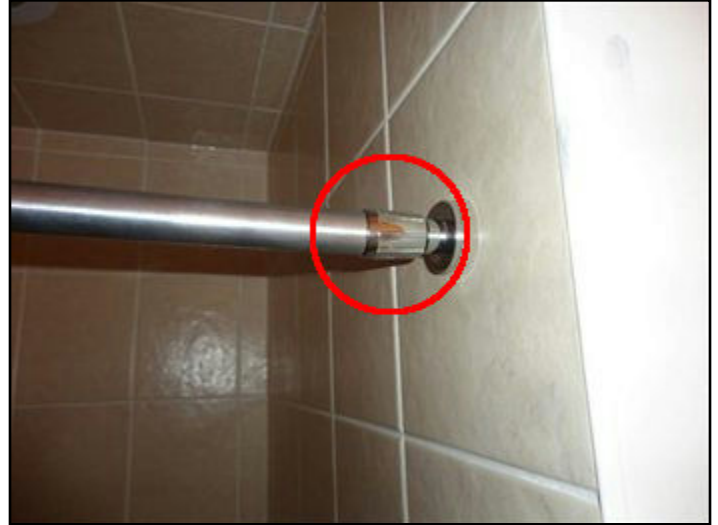
7. Defective plumbing fixtures, appliances or...

### 6. Condition: • [Defective plumbing fixtures, appliances or trim fittings](#)

Dented curtain rod

Location: Second Floor Bathroom

Task: Replace

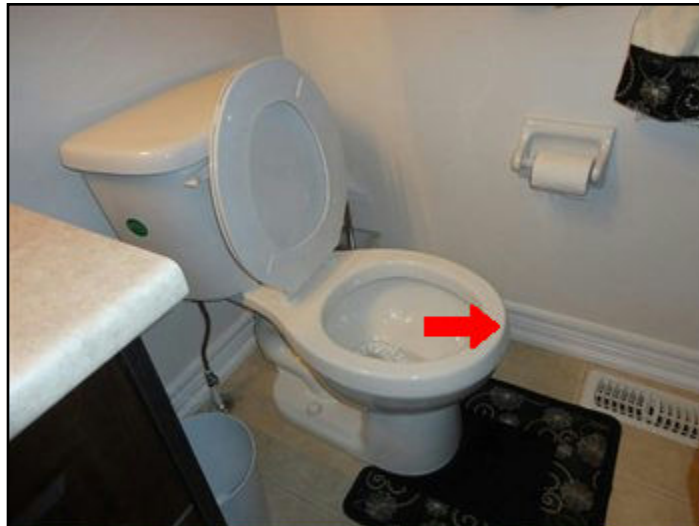
9. Defective plumbing fixtures, appliances or...

### 7. Condition: • [Defective plumbing fixtures, appliances or trim fittings](#)

Toilet spilled out while flushing it

Location: Second Floor Bathroom

Task: Replace

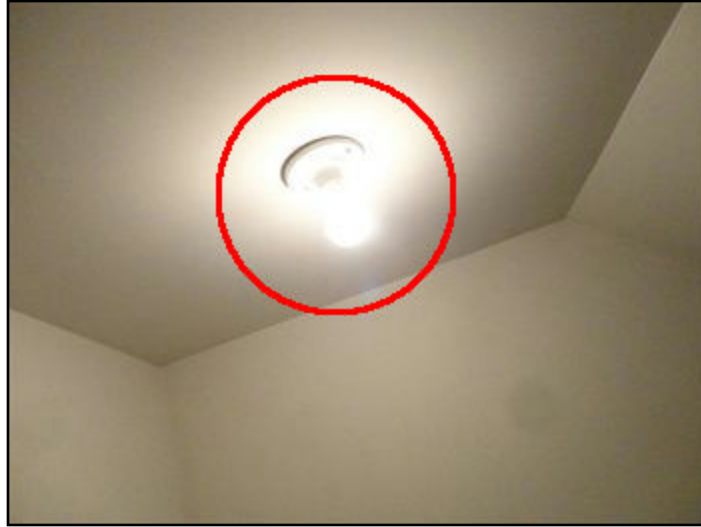
10.

**8. Condition:** • Missing electrical fixture cover. Basement staircase considered as finished areas

**Location:** Basement Staircase

**Task:** Replace

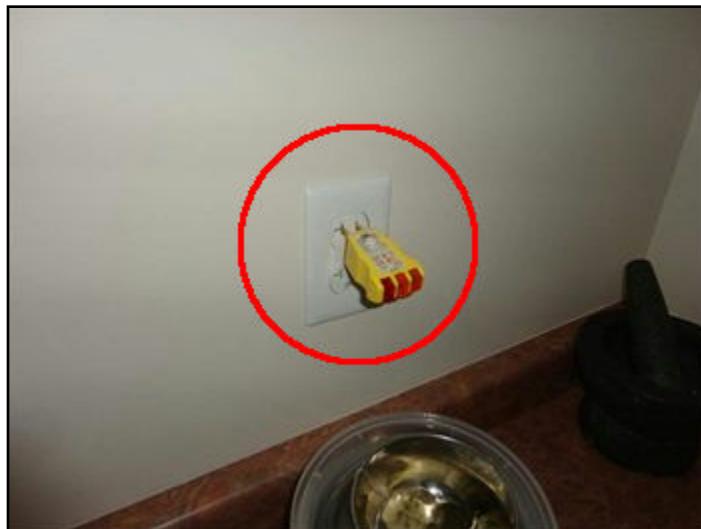
11.

**9. Condition:** • Difficult to use the electrical outlets. cannot plugged in.

**Location:** First Floor Kitchen

**Task:** Replace

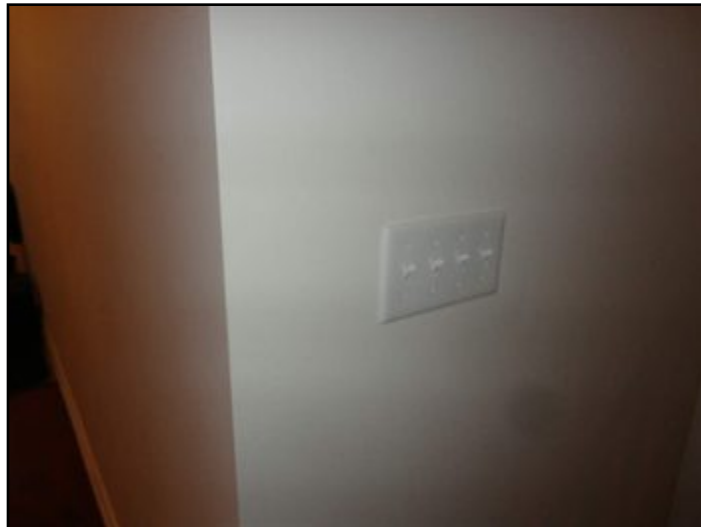
12.

**10. Condition:** • Electrical switch are not in sequence / order

**Location:** First Floor Staircase

**Task:** Repair

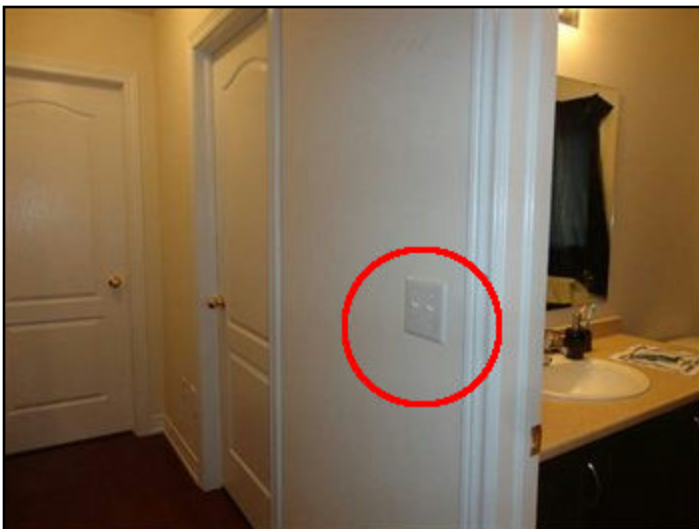
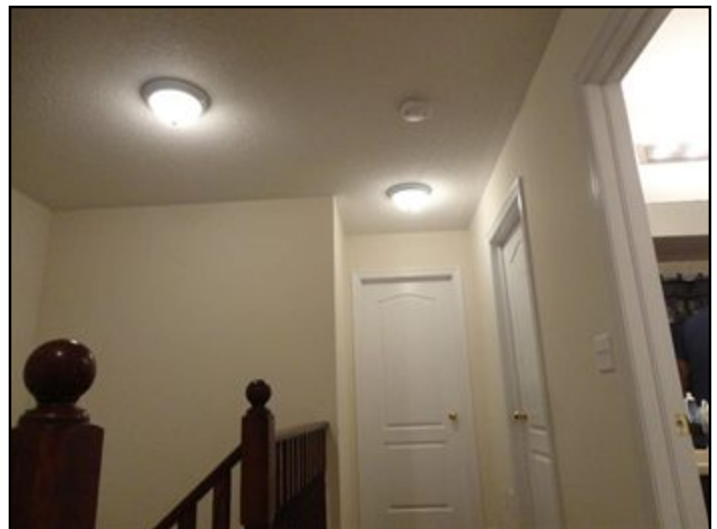
13.

**11. Condition:** • Bathroom exhaust fan & lights switch installed on the outside of the bathroom. It is inconvenience to the home owner to use this washroom. In common practice the bathroom electrical switches always install inside of the bathroom. If someone turn this switch off accidentally while someone taking the shower, its a safety concerned;

**Location:** Second Floor Bathroom

**Task:** Replace

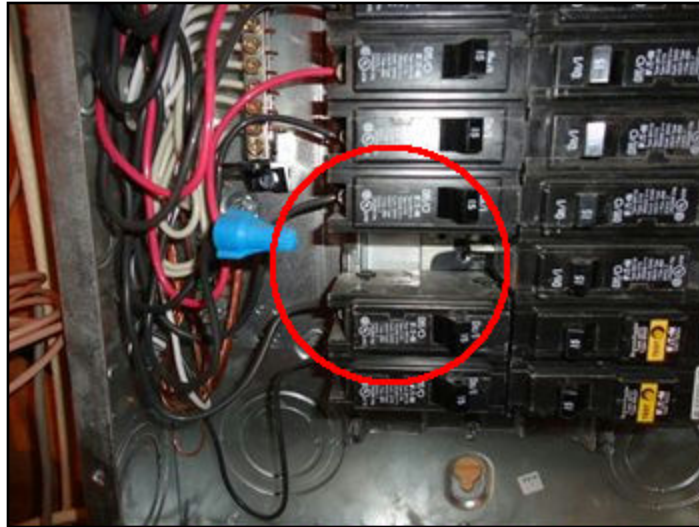
15. *Electrical fixture doesn't work*

**12. Condition:** • [Electrical fixture doesn't work](#)

Dishwasher outlet inoperative / Missing the breaker

**Location:** First Floor Kitchen

**Task:** Repair

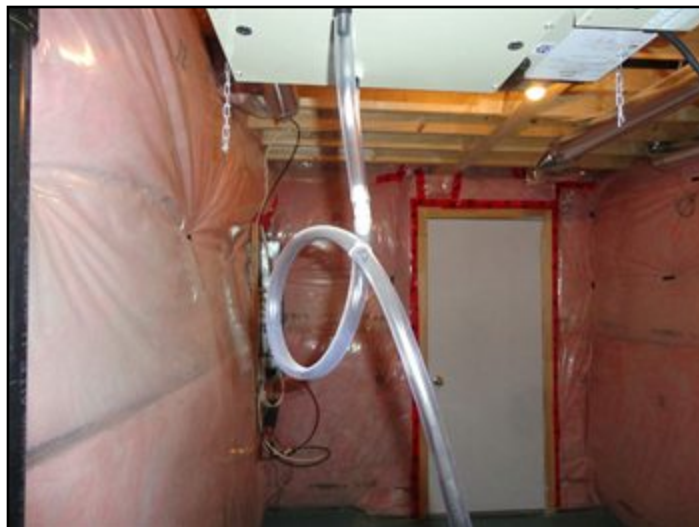
16. *Condensate line is blocked*

**13. Condition:** • Extend condensation hose for HRV to drain

**Location:** Basement

**Task:** Repair or replace

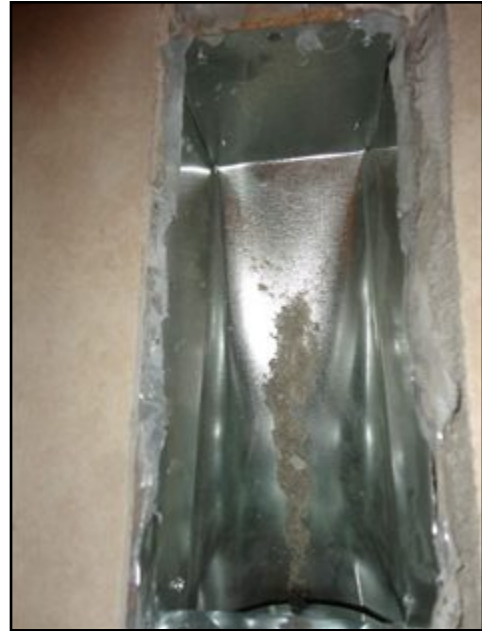
17.

**14. Condition:** • Duct cleaning required

**Task:** Remove

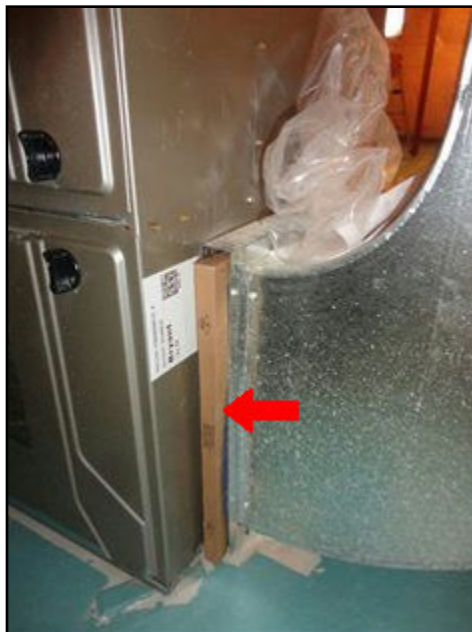
19.

**15. Condition:** • Missing furnace filter cover plate

**Location:** Basement

**Task:** Provide

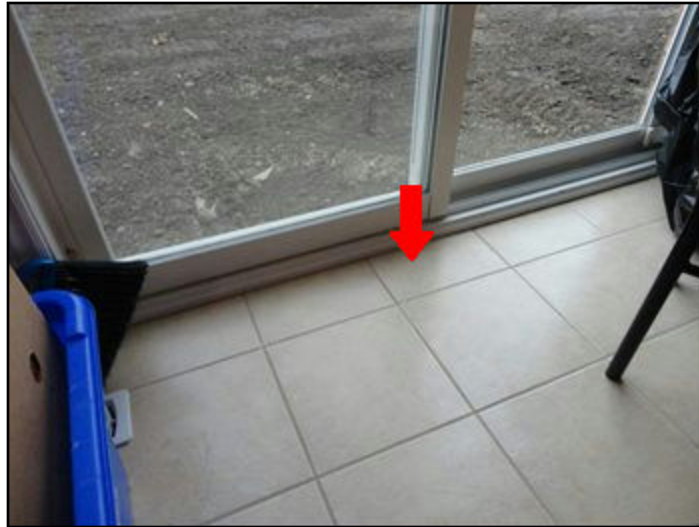
*20. Air infiltration through windows and doors*

**16. Condition:** • [Air infiltration through windows and doors](#)

Drafty patio door

**Location:** West First Floor Kitchen

**Task:** Repair

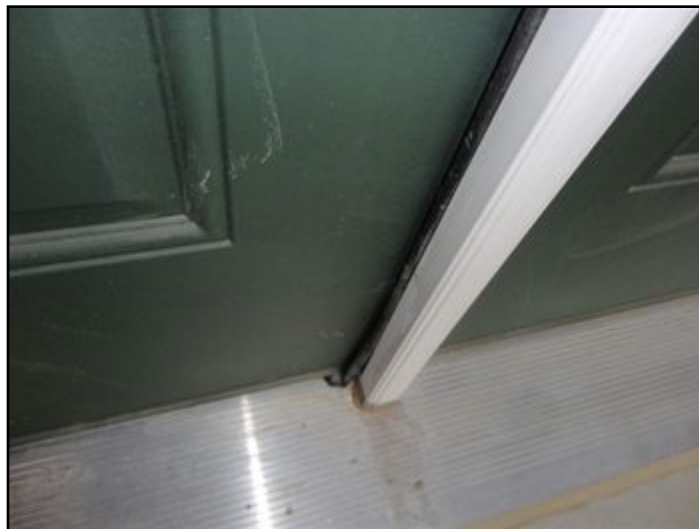
*21. Air infiltration through windows and doors*

**17. Condition:** • [Air infiltration through windows and doors](#)

**Location:** Various

**Task:** Repair

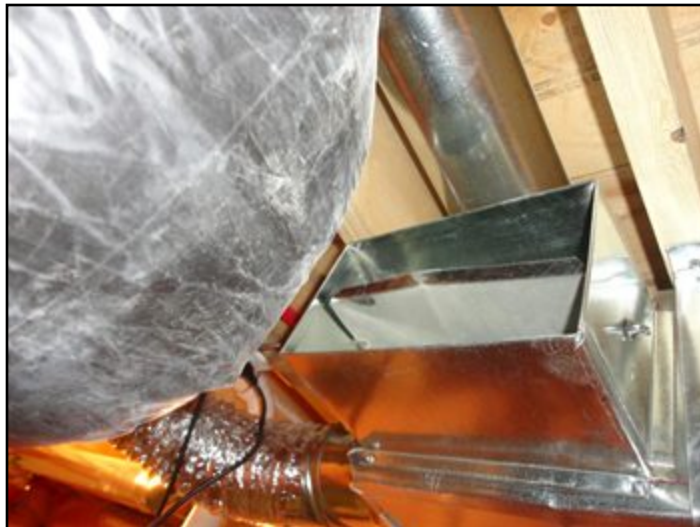
22. Heating, ventilating or air conditioning...

**18. Condition:** • [Heating, ventilating or air conditioning \(HVAC\) systems not installed properly](#)

Damaged damper

**Location:** Basement

**Task:** Replace

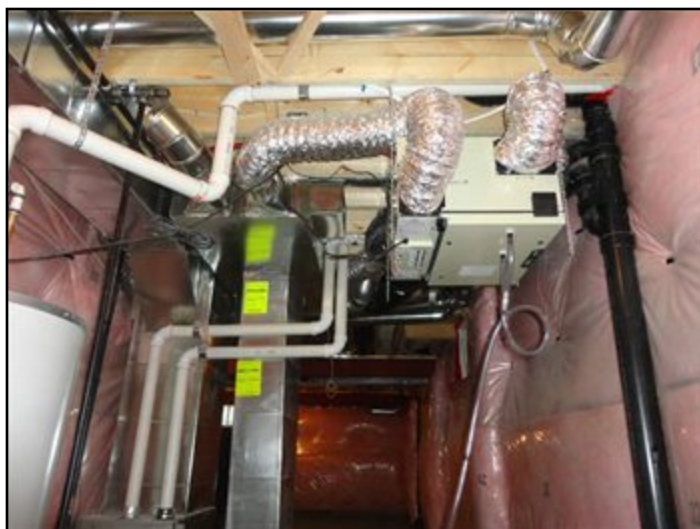
23. Heating, ventilating or air conditioning...

**19. Condition:** • [Heating, ventilating or air conditioning \(HVAC\) systems not installed properly](#)

HRV configuration, poorly done / set

**Location:** Basement

**Task:** Repair

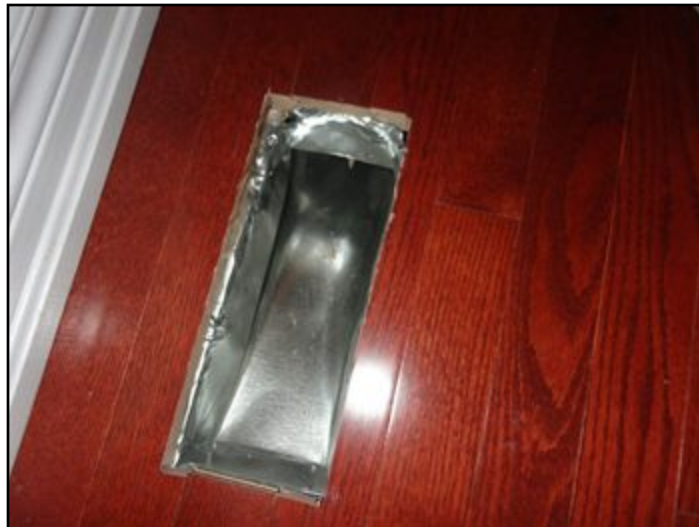
24. *There are gaps between heat diffusers, cold...*

**Location:** Basement Furnace Room**Task:** Repair**23. Condition:** • [There are gaps between heat diffusers, cold air return grilles and ventilation grilles and the adjacent surfaces](#)**Location:** First Floor**Task:** Repair

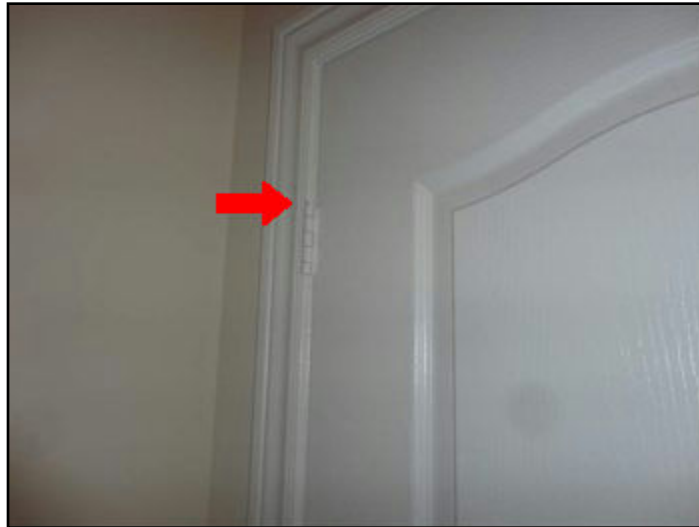
25. Hinges are painted

**TARION \ Interior finishing****24. Condition:** • [Hinges are painted](#)**Location:** Various First Floor Foyer**Task:** Repair

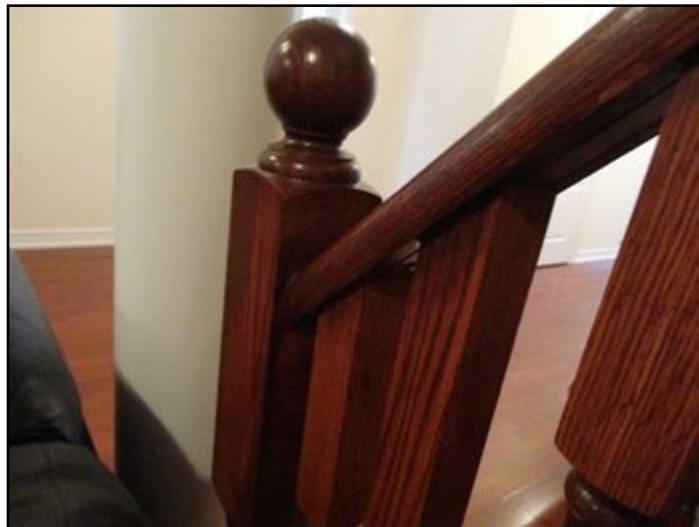
26. Material in interior finish are mismatched

**25. Condition:** • Material in interior finish are mismatched

Stain doesn't matches

**Location:** First Floor Staircase

**Task:** Replace

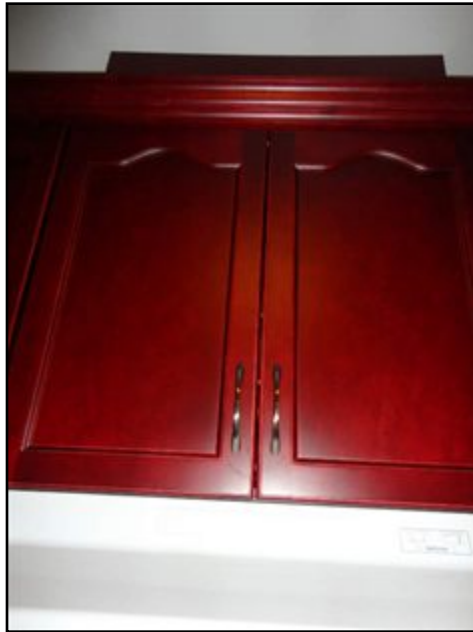
27. Gap between cabinets and ceilings or walls

**26. Condition:** • [Gap between cabinets and ceilings or walls](#)

**Location:** First Floor Kitchen

**Task:** Repair

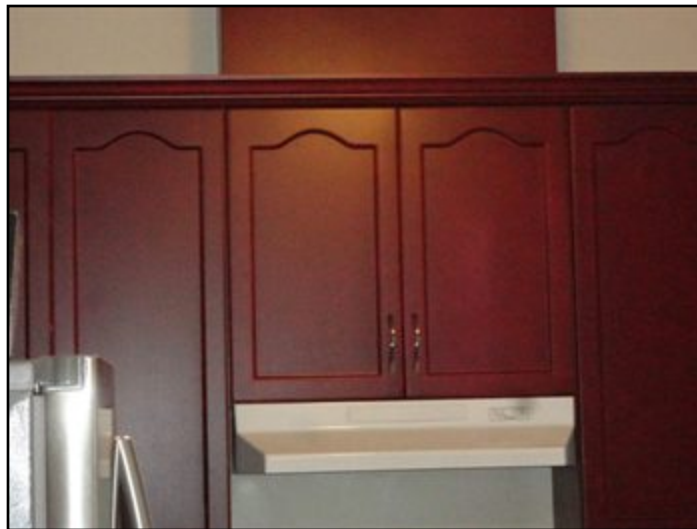
28. Cabinet door or drawer binds or rubs

27. Condition: • [Cabinet door or drawer binds or rubs](#)

Location: First Floor Kitchen

Task: Repair

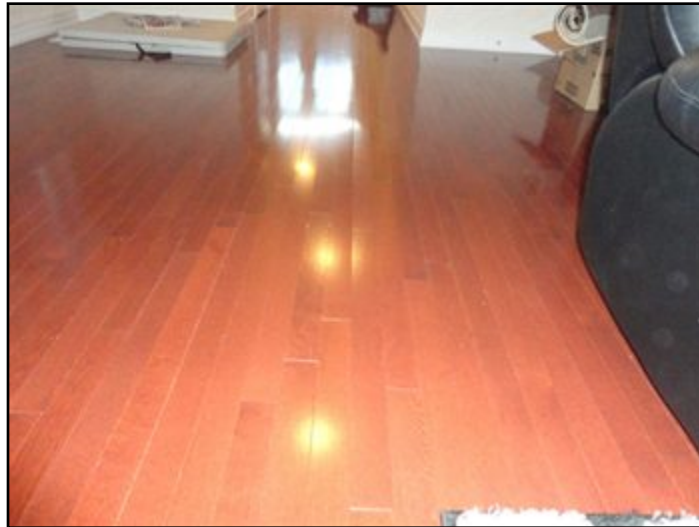
29. Floor is uneven

28. Condition: • [Floor is uneven](#)

Location: First Floor Living Room

Task: Repair or replace

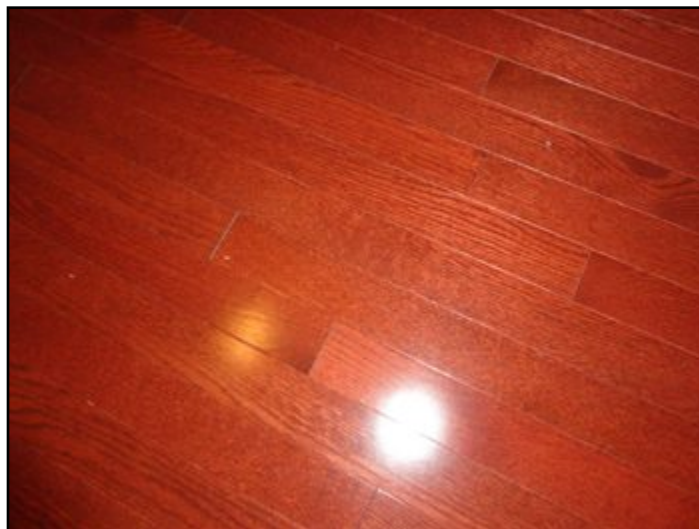
30. Floor finish on wood flooring is not uniform

**29. Condition:** • [Floor finish on wood flooring is not uniform](#)

Gaps between the hardwood strips

**Location:** Various

**Task:** Repair or replace

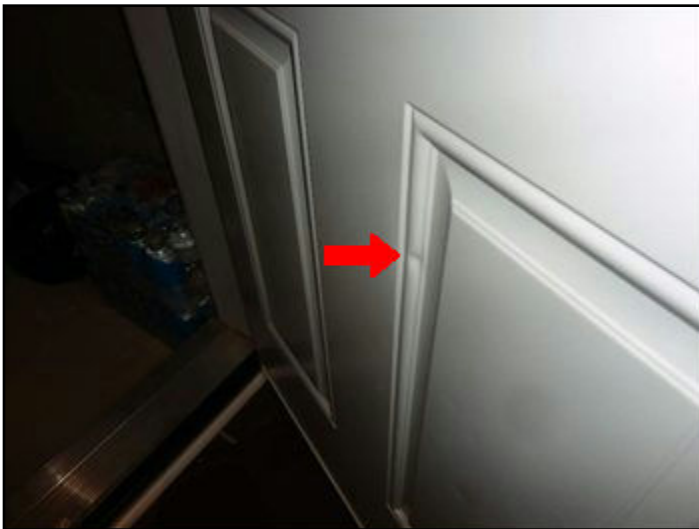
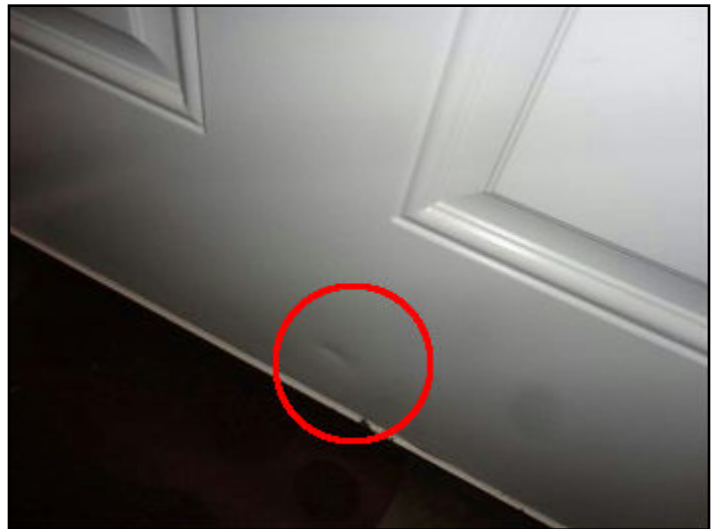
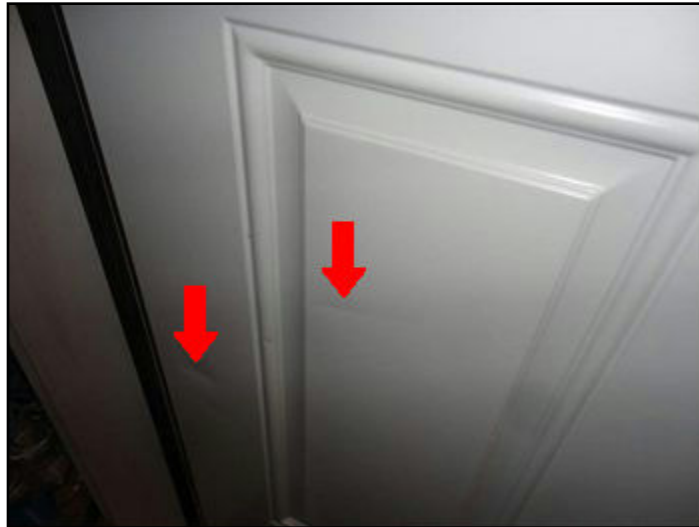
32.

31. **Condition:** • Man-door damaged / dented

**Location:** First Floor Garage

**Task:** Replace

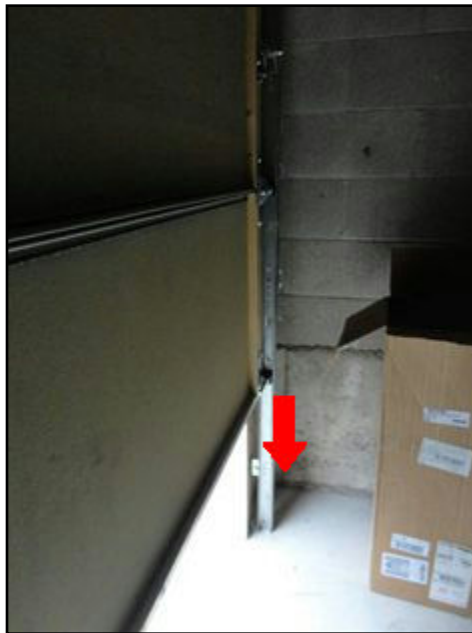
35. *Garage doors do not operate properly*

**32. Condition:** • [Garage doors do not operate properly](#)

Difficult to close.

**Location:** Exterior Garage

**Task:** Repair

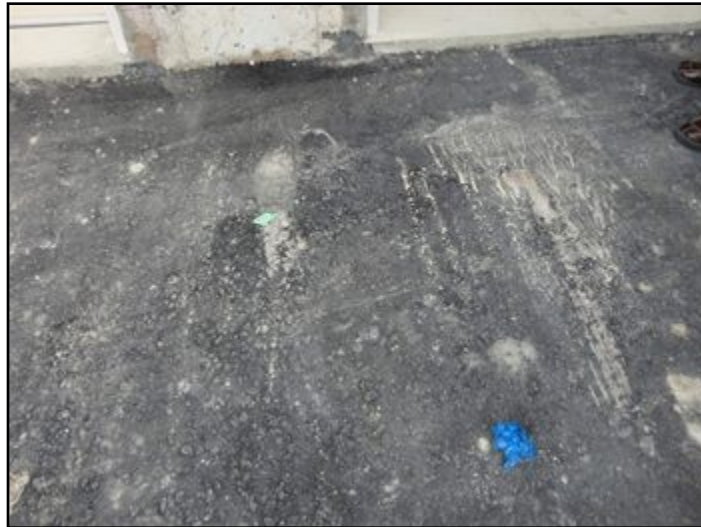
36. Driveway has settled

**33. Condition:** • [Driveway has settled](#)

Poorly laid driveway. Needed repair / reconstruction

**Location:** Exterior

**Task:** Repair

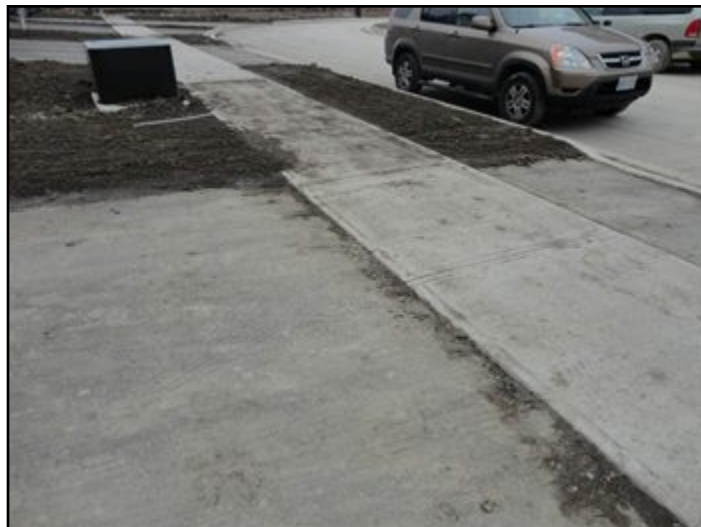
37. Water ponding in surface grading of the site

35. Condition: • [Water ponding in surface grading of the site](#)

Driveway

Location: Exterior

Task: Repair

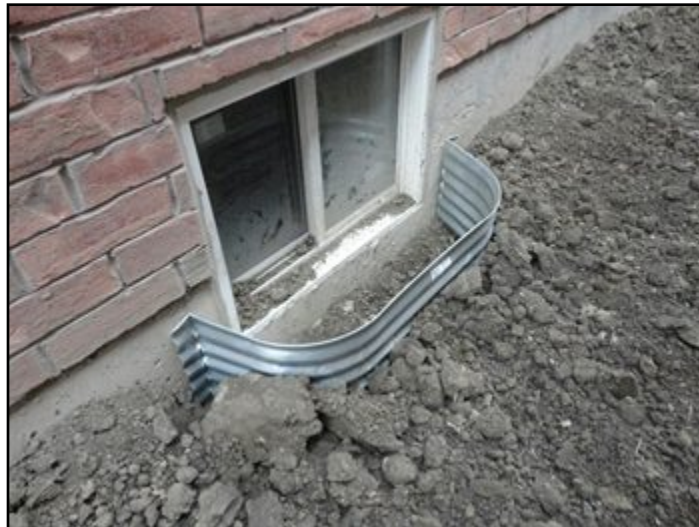
38. Water ponding in surface grading of the site

**36. Condition:** • [Water ponding in surface grading of the site](#)

**Location:** Exterior

**Task:** Improve

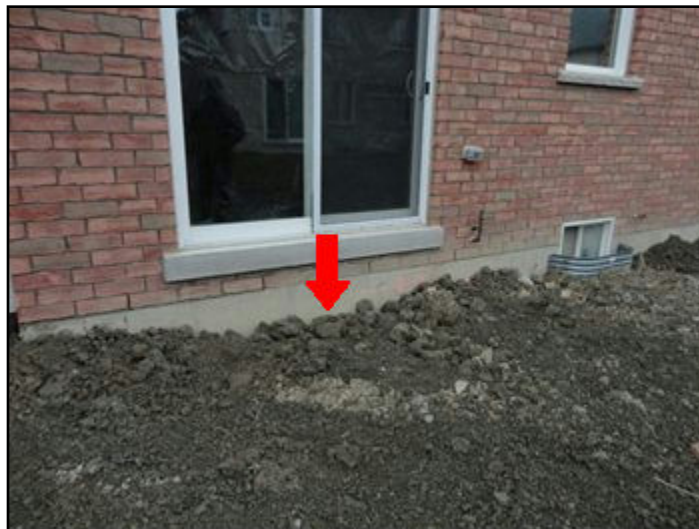
39.

**37. Condition:** • Missing steps to backyard

**Location:** West Exterior Deck

**Task:** Provide

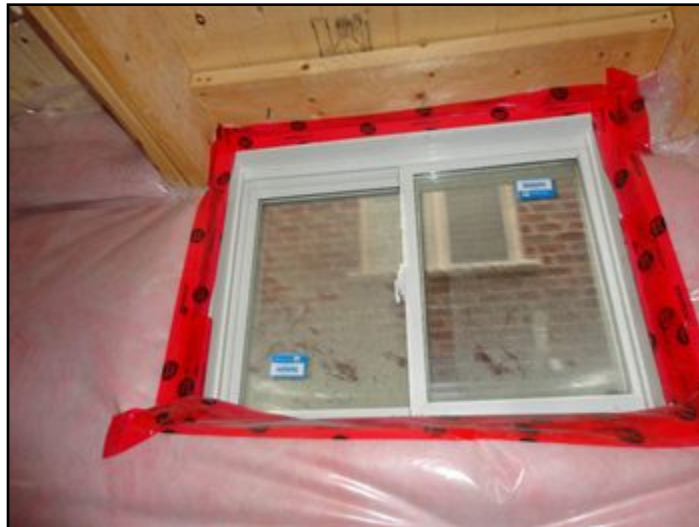
40.

**38. Condition:** • Missing window screens

**Location:** Basement

**Task:** Provide

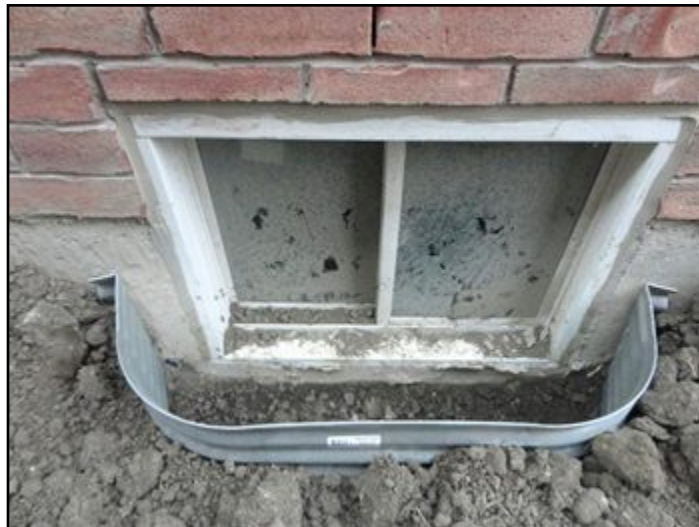
41. *Landscaping incomplete*

**39. Condition:** • Landscaping incomplete

**Location:** Throughout

**Task:** Improve

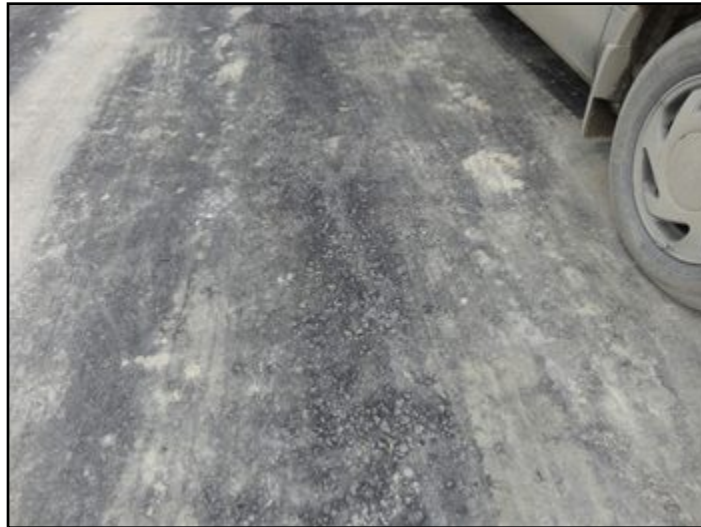
*42. Driveway has settled*

**40. Condition:** • Landscaping incomplete

uncompleted driveway

**Location:** Front Exterior

**Task:** Improve

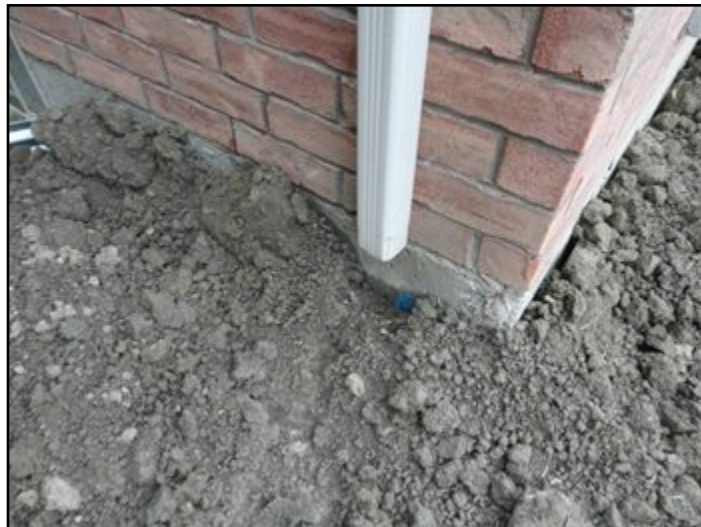
*43. Missing splash blocks/rainwater leaders*

**41. Condition:** • Missing splashblocks/rainwater leaders

**Location:** Throughout

**Task:** Provide
